Manhole Inspection Summary

Manhole # S06AA2024MH

Insp Date: **6/23/06 11:41 AM**

Location Address: **3819 LABYRINTH RD**

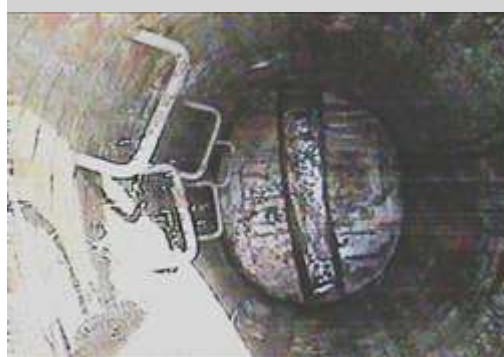
Top View

Comments **Mineral deposits throughout the interior of the MH.**

Adjustment and Corbel infiltration. Bench debris.

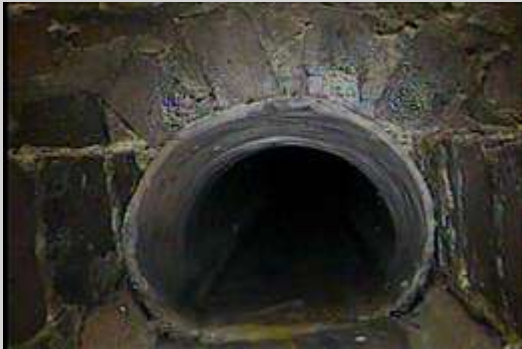
8 in. Circular Gravity Sewer Pipe Out @ 12 O'Clock

Pipe Material: **Unknown** ☒ Pipe Lined

Invert Depth: **10.68** (ft.) Flow Characteristics: **Fast**

Infiltration: **None** Pipe Seal Cond: **Unknown**

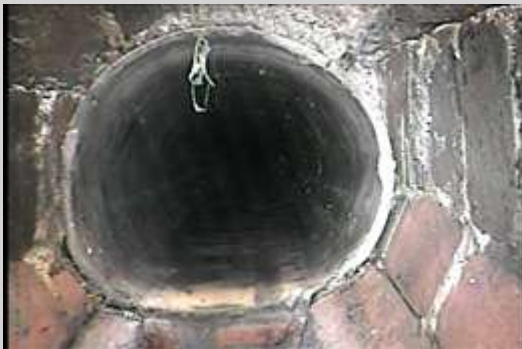
8 in. Circular Gravity Sewer Pipe In @ 6 O'Clock

Pipe Material: **Clay** ☒ Pipe Lined

Invert Depth: **10.62** (ft.) Flow Characteristics: **Fast**

Infiltration: **None** Pipe Seal Cond: **Unknown**
